**IMPORTANT** - This is **NOT** an official Federal Aviation Administration list of Airworthiness Directives. See your Licensed Airframe and Powerplant Mechanic who also holds an Inspection Authorization for a complete up to date list of Airworthiness Directives.

This list is in three parts - Part 1 are AD's for the Stinson, Part 2 are AD's for the Franklin engine, Part 3 are AD's for Propellers used on Stinsons, Part 4 are AD's for MARVEL-SCHEBLER Carburetor. **NOTE** - many Stinsons have different engines and/or propellers installed by supplemental type certificate (STC). This list of AD's concerns the Stinson as delivered.

### **Part 1 - Stinson Airplane**

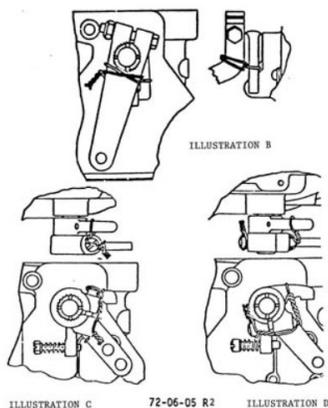
(2) Inspect the throttle arm on Marvel Schebler MA-3, MA-3A, MA-3PA, MA3-SPA, and MA-4SPA carburetors to determine whether it has a spotfaced or milled flat for the head of the clamping screw. Replace any arm having a milled flat with one having a spotfaced flat. If not already installed, install a Marvel Schebler P/N A15-493 clamping screw (No. 10-24 x 5/8 slotted drilled fillister head) in the throttle arm. Torque the clamping screw to 20-28 in.-lb. and inspect the slot in the end of the arm for clearance. If the slot has closed so that no clearance remains, replace the arm and retorque to the above specifications. After the specified torque is established safety wire the throttle arm and clamping screw to the throttle stop as shown in Illustration A.

To prevent looseness or separation of the throttle arm, accomplish the following or any equivalent procedure approved by the Manager, New York Aircraft Certification Office, FAA, New England Region.

(1) Inspect the throttle arm to verify that it is bottomed against the shoulder on the throttle stop and positioned so that full throttle travel is obtained, and if not, loosen clamping screw and reposition arm and/or re-rig control system in accordance with airplane manufacturers' maintenance instructions to obtain these conditions.
